MAPLE LAKE DAM

**NDI ID NO. PA-01026
DER ID NO. 57-38**

**PHASE I INSPECTION REPORT
NATIONAL DAM INSPECTION PROGRAM**

AUGUST 1981

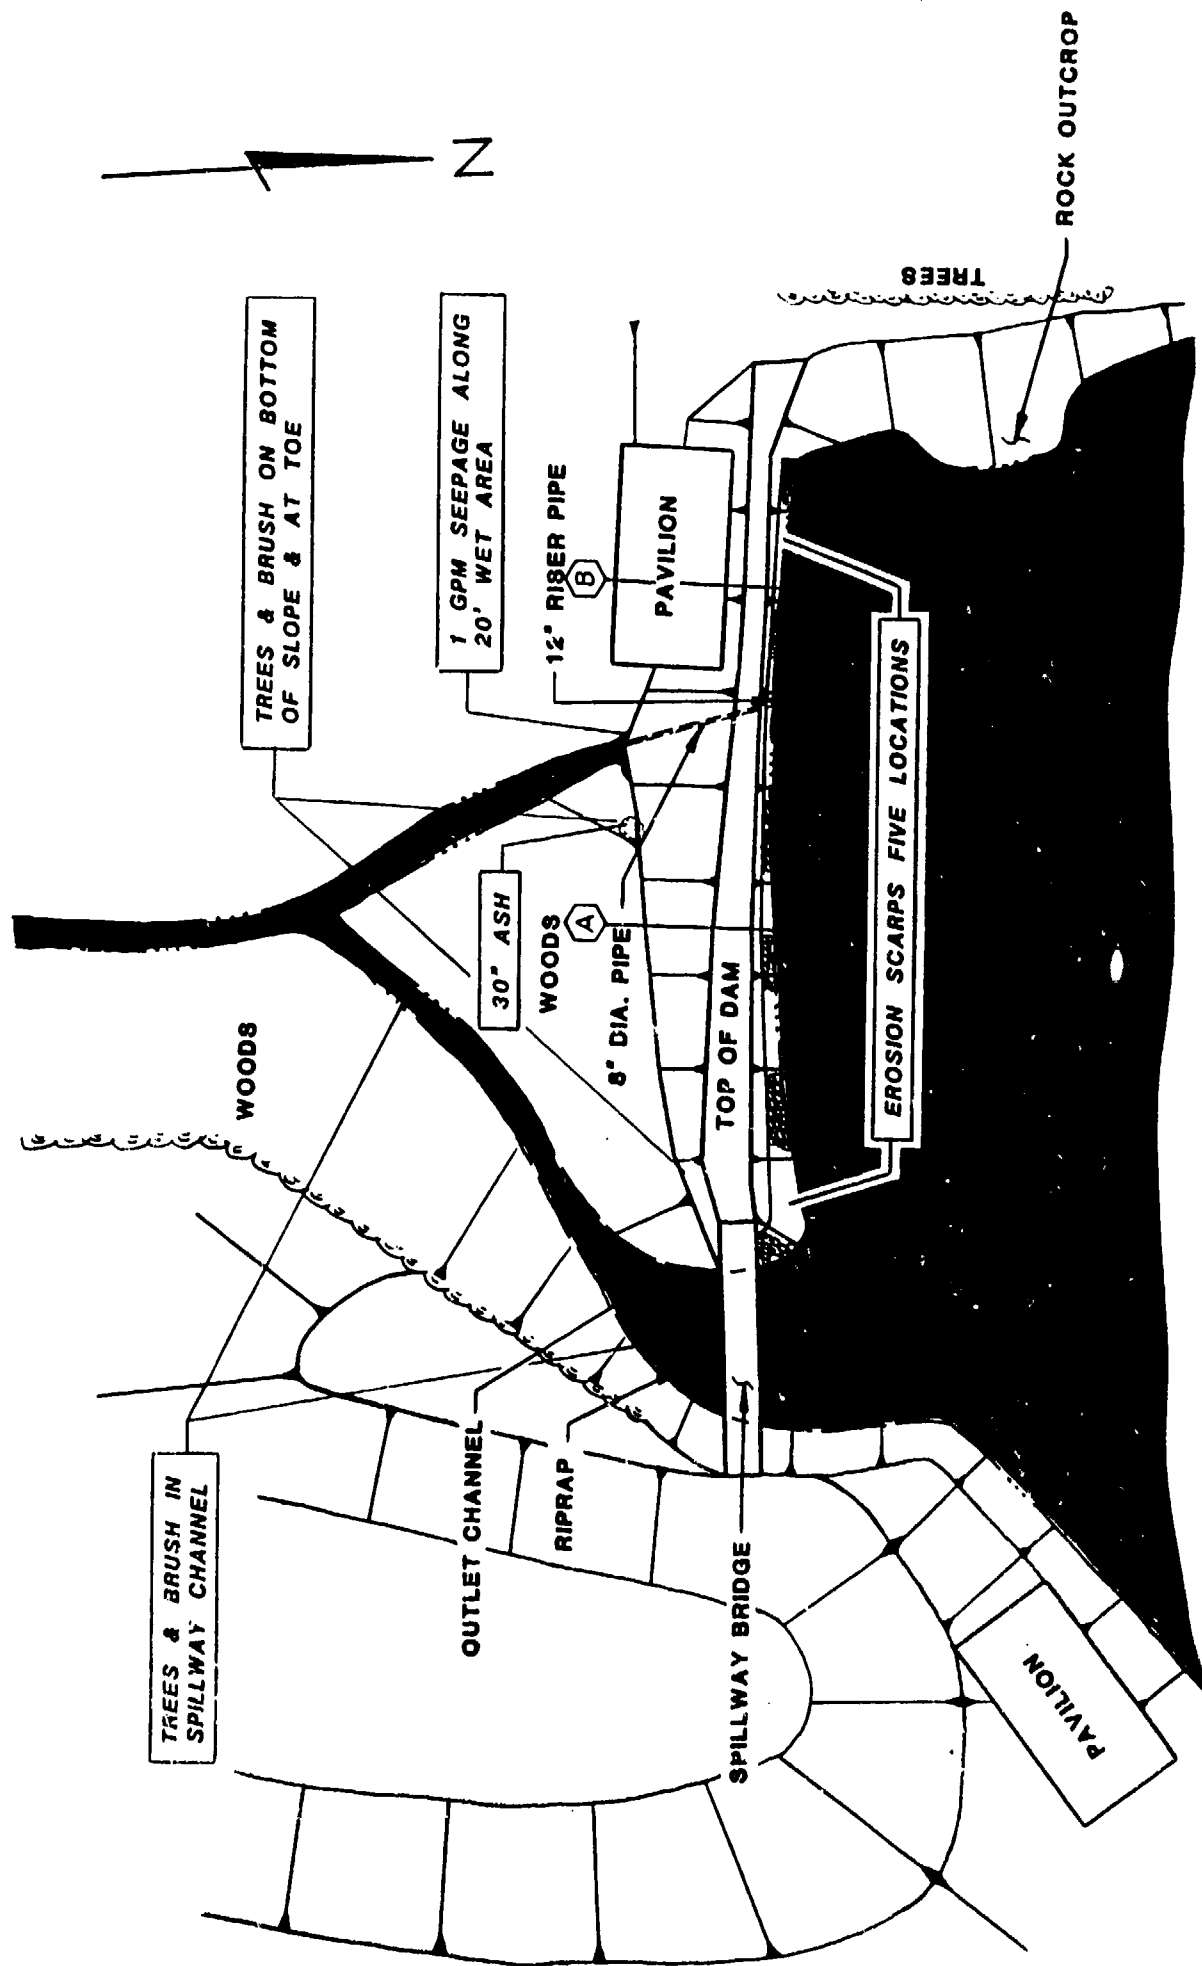
MAPLE LAKE DAM
GENERAL PLAN - FIELD INSPECTION NOTES

a. General: The overall appearance of the dam is good. Deficiencies observed during the field inspection are noted on the General Plan, Exhibit A-1, and are described in the subsequent paragraphs. The profile and typical sections of the dam are presented in Exhibits A-2, A-3 and A-4 and are based on field survey made on the day of the inspection. The survey datum for this inspection is based on interpolation of the USGS contour map, presented in Exhibit E-1, Appendix E. The elevations shown on the design drawings (Exhibits E-2, E-3 and E-4) are based on a different datum than that of the USGS map. Therefore, to convert the elevations shown on the appended design drawings to the elevations used in this report, it is necessary to add 20 feet to the elevations shown on the appended drawings. On the inspection date (7/14/1981), the lake level was at normal pool which is the crest of the service spillway (elevation 1575.6 above mean sea level). Visible features of the dam and appurtenant structures are depicted in photographs, presented in Appendix C.
